PALDISKI TOWN CENTRAL BOILER HOUSE

REMEDIATION FEASIBILITY STUDY

FEBRUARY 1997

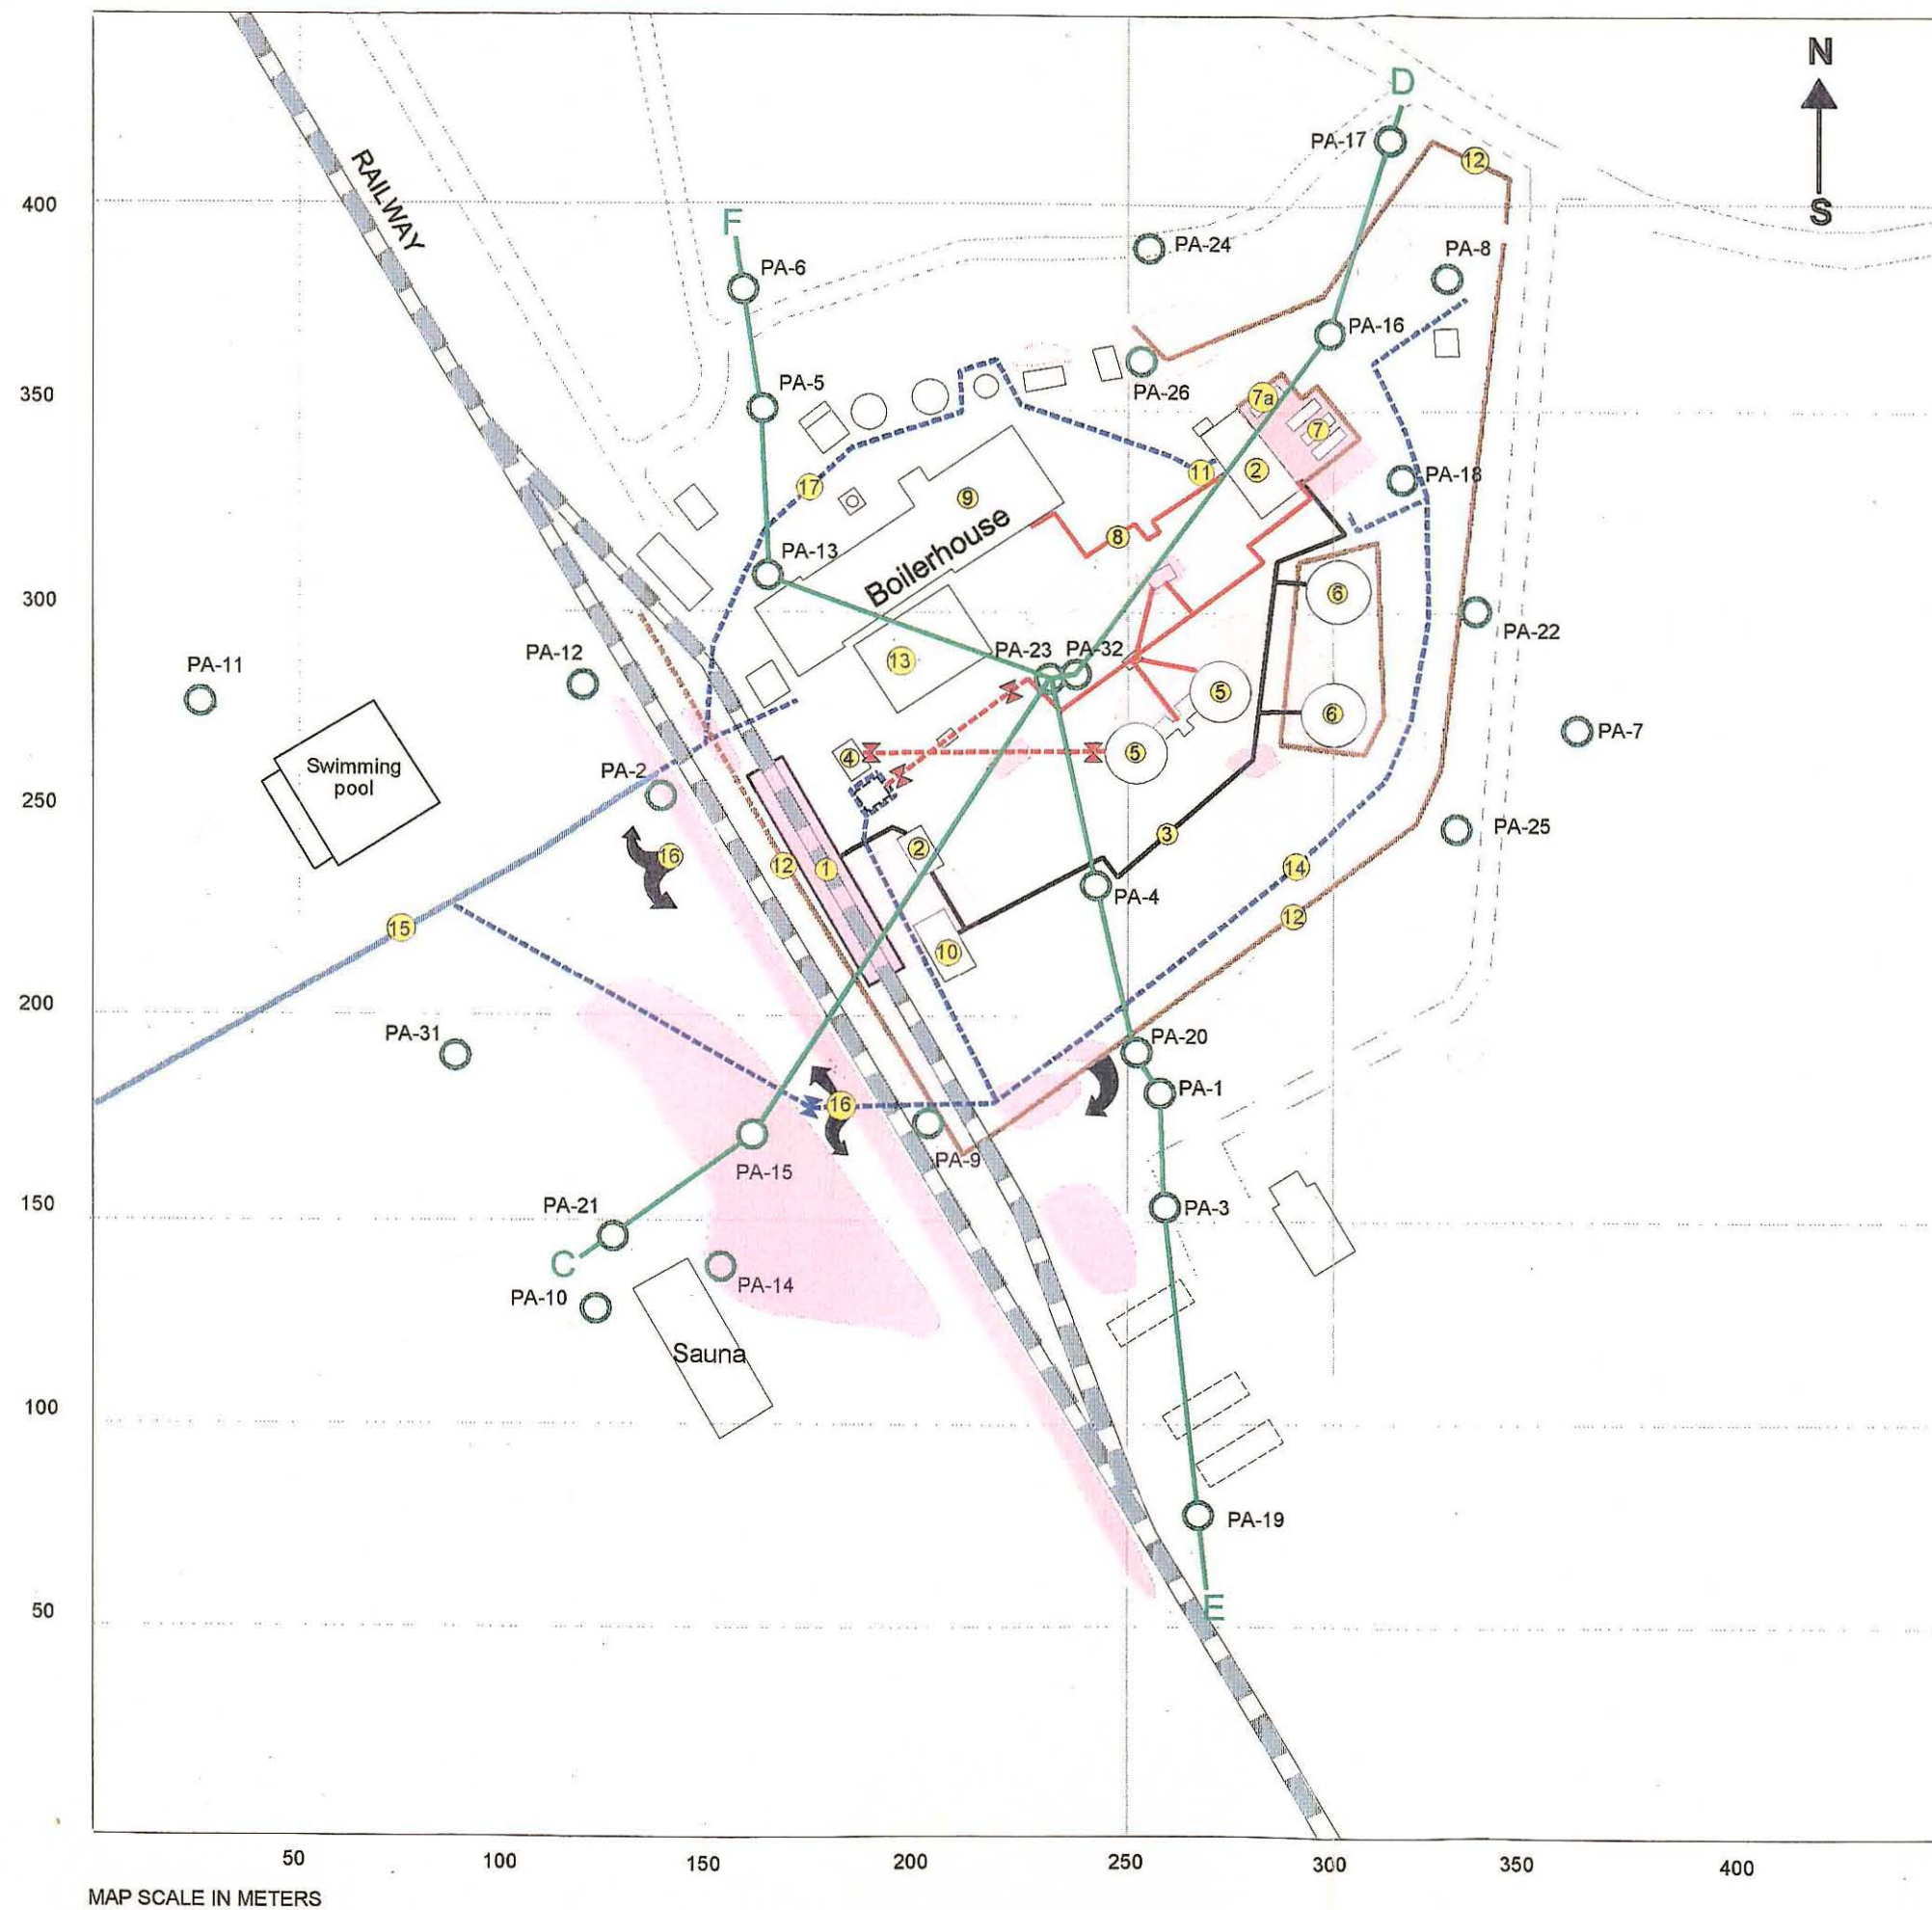
FIGURE 3.1 LOCATIONS OF INSTALLATIONS, BOREHOLES AND HOT SPOTS

There are four black oil storage tanks on the central boiler house site (locations are shown by number in figure 3.1):

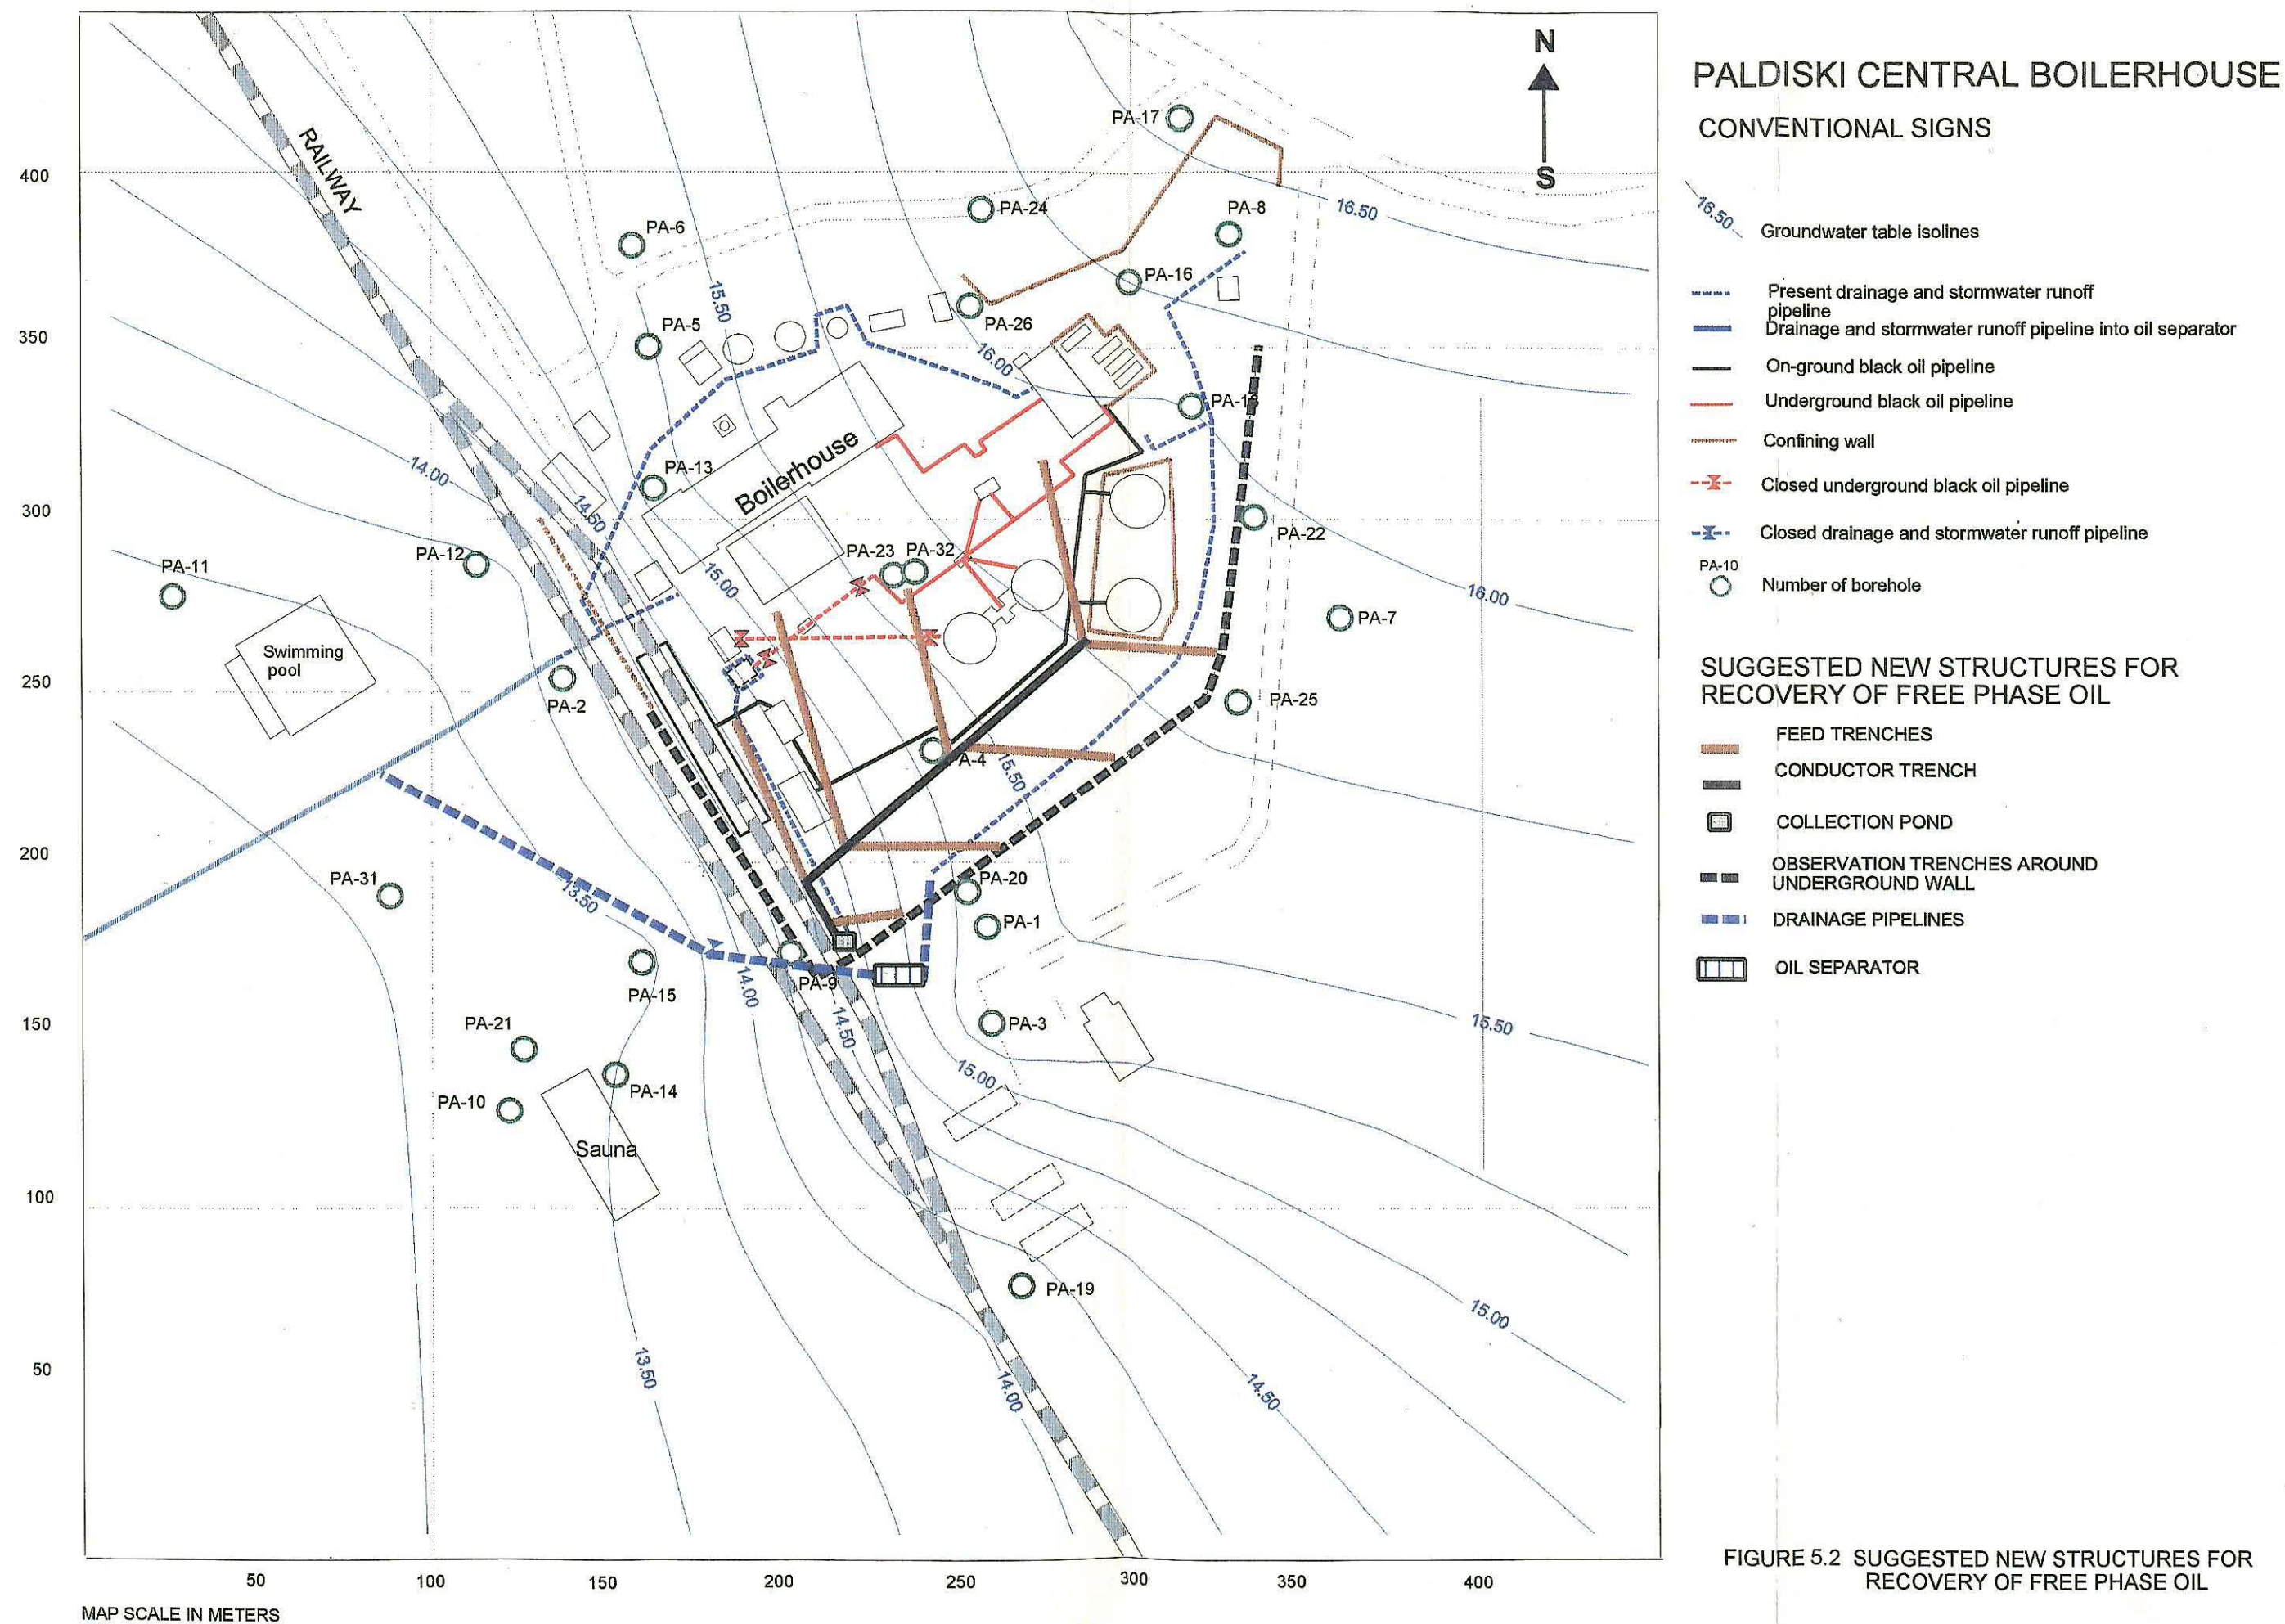
Preliminary locations of the trenches and the collection pond are shown in figure 5.2

Observation and pumping trenches should be built on both sides of the underground concrete wall in the southern and western part of the area. The level of oil and water in the trench inside the confining wall must be kept permanently under the top of subterranean concrete wall to prevent the spreading of oil.

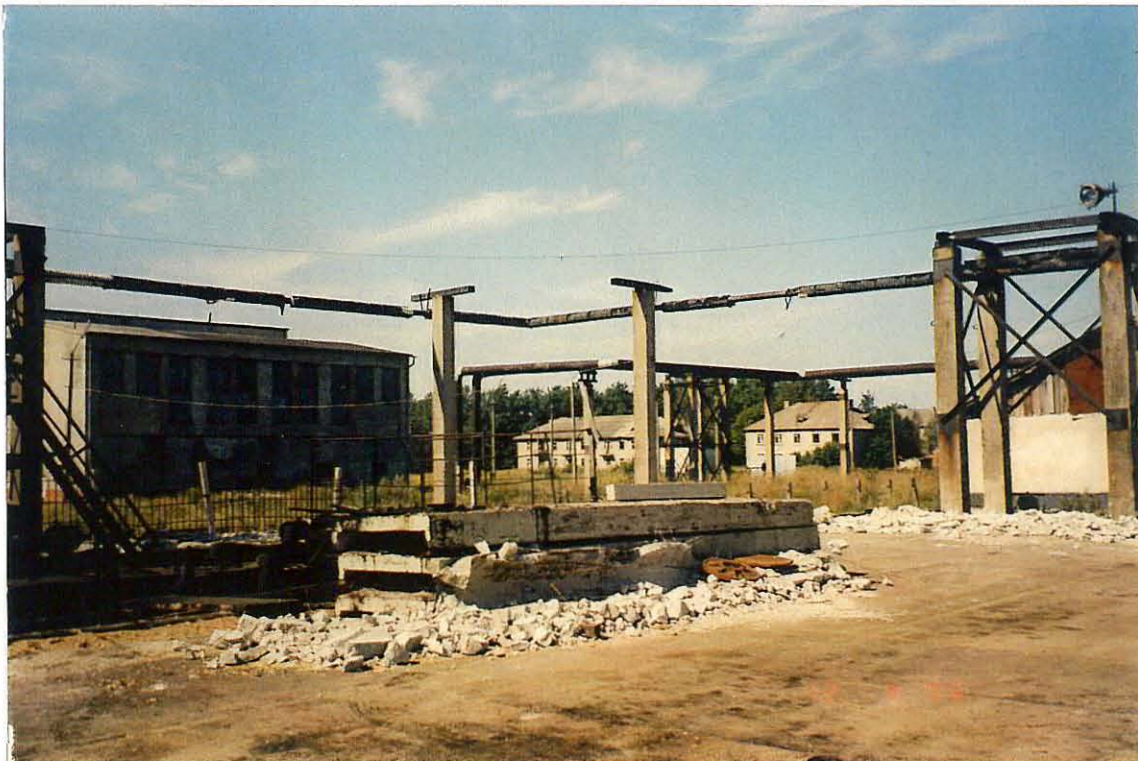
Photo 2. Area where the underground tank is situated (viewed from the east).

- emptying and demolition of the two 1000 m³ oil tanks (no 5), which are out of use. Tests and repairs should be carried out if it is planned to use the tanks again in the future.
- testing and repairing of the two 2000 m³ oil tanks (no 6), which are in use
- testing and repairing of the four 100 m³ oil tanks (no 7), which are in use
- testing and repairing of the oil pipes (no 3 and 8), which are in use
- emptying, plugging and demolition of oil pipes, which are not in use
- demolition of the old underground tank (no 4), which is not in use

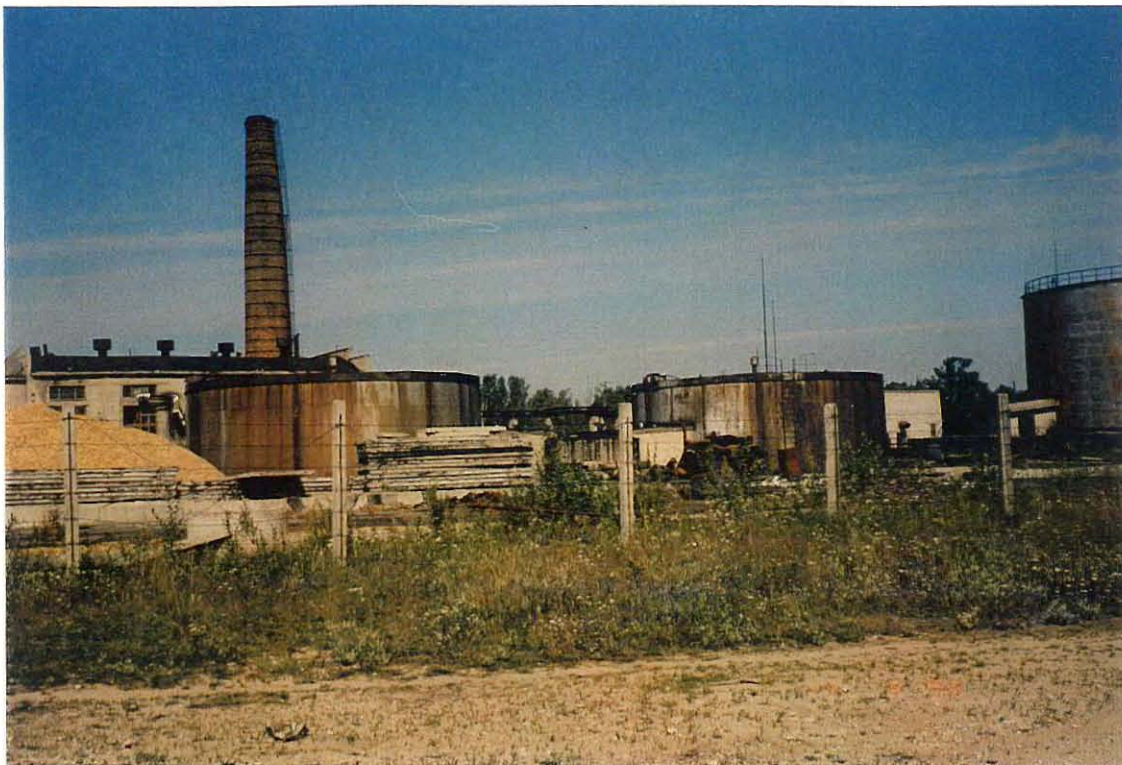
The old black oil storage area (2 x 1000 m³ tanks) has reached the end of its useful life and is apparently the cause of most of the contamination at the site. As part of a construction project in the end of the 1980's, concrete slabs were placed on the areas of soil that were saturated with black oil.

Photo 3. Two old 1000 m³ storage tanks, not in use (viewed from the south).

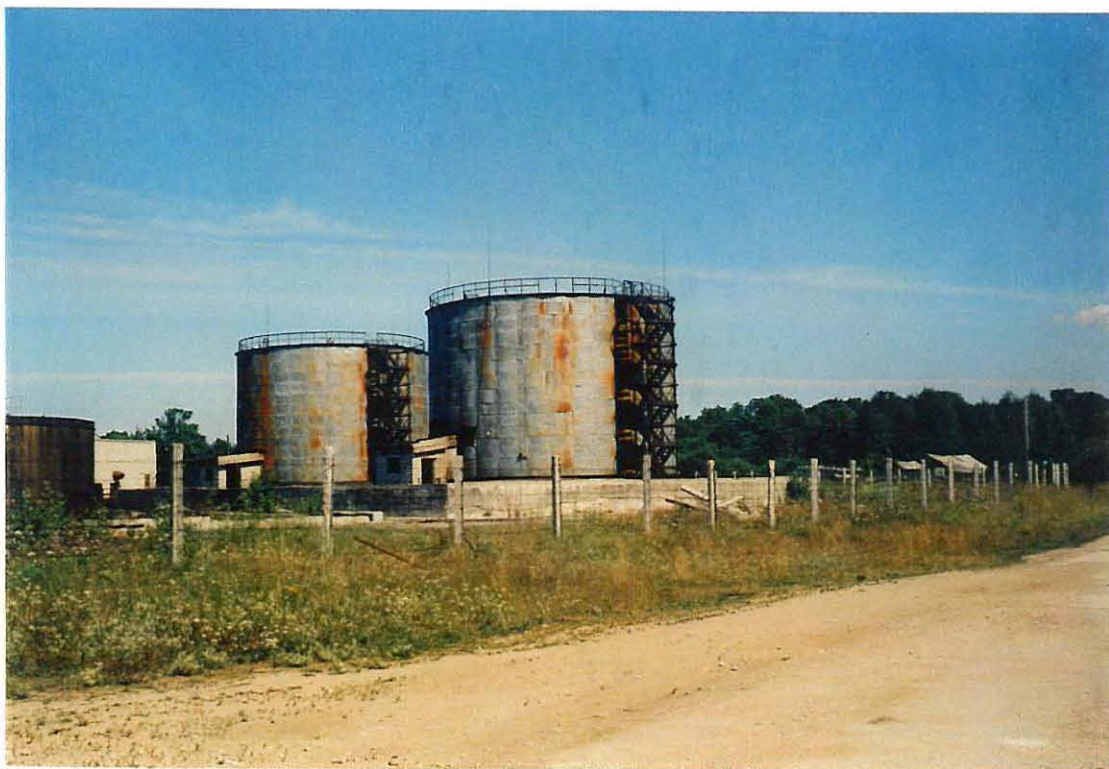
Photo 4. Two new 2000 m³ storage tanks (viewed from the south).

The testing and repairing of the tanks no 6 and 7 and the pipelines (Section 5.1.1) will cost round 0.6 million EEK. The cost will vary over a large range depending on the extent of the repair required. The cost of demolition of the tanks no 5 and 4 has not been estimated.

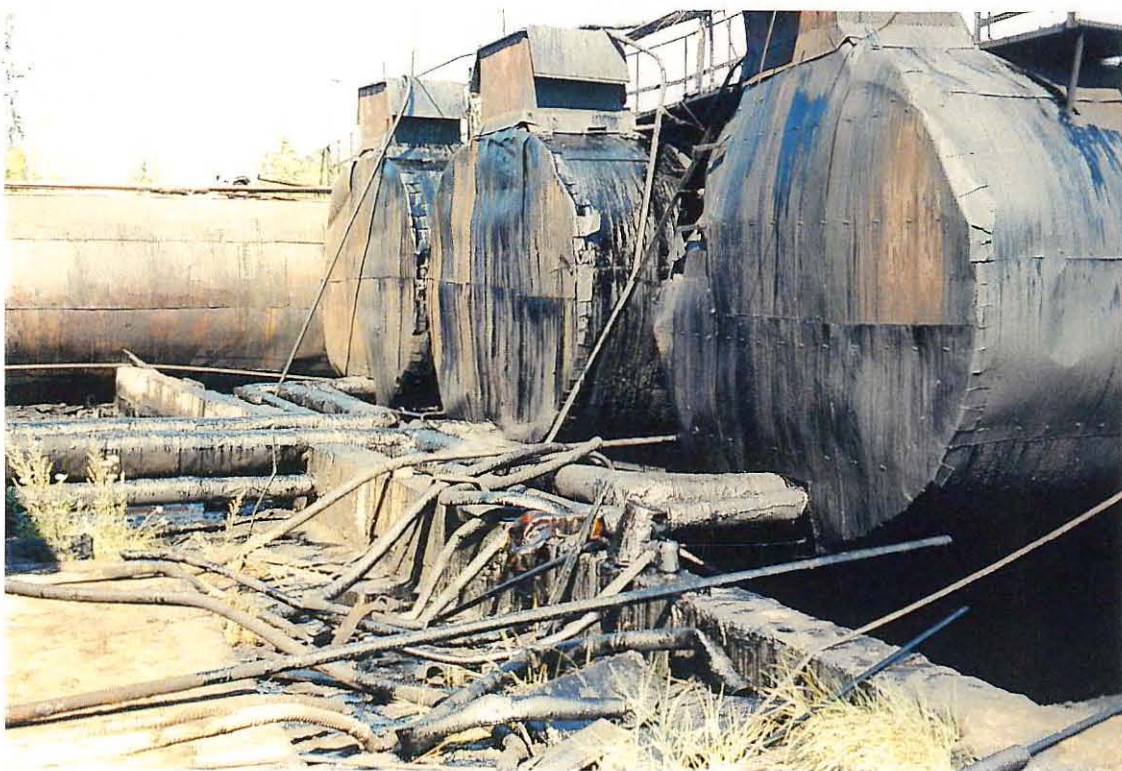
The handling of the oil in the area of the four 100 m³ storage tanks is possibly one reason for the pollution of the area and represents a source of risk of future leakages to the ground. The handling procedures for the oil should be changed so that oil is stored in the tanks and the protection basin be kept clean and empty during normal operations. Only then can the basin work as an emergency basin and the leaks from the tanks be observed. In addition, there is no proof as to the integrity of the basin to ensure that it does not leak oil to the ground and groundwater.

Photo 5. Four 100 m³ oil tanks in concrete basin (viewed from the south).

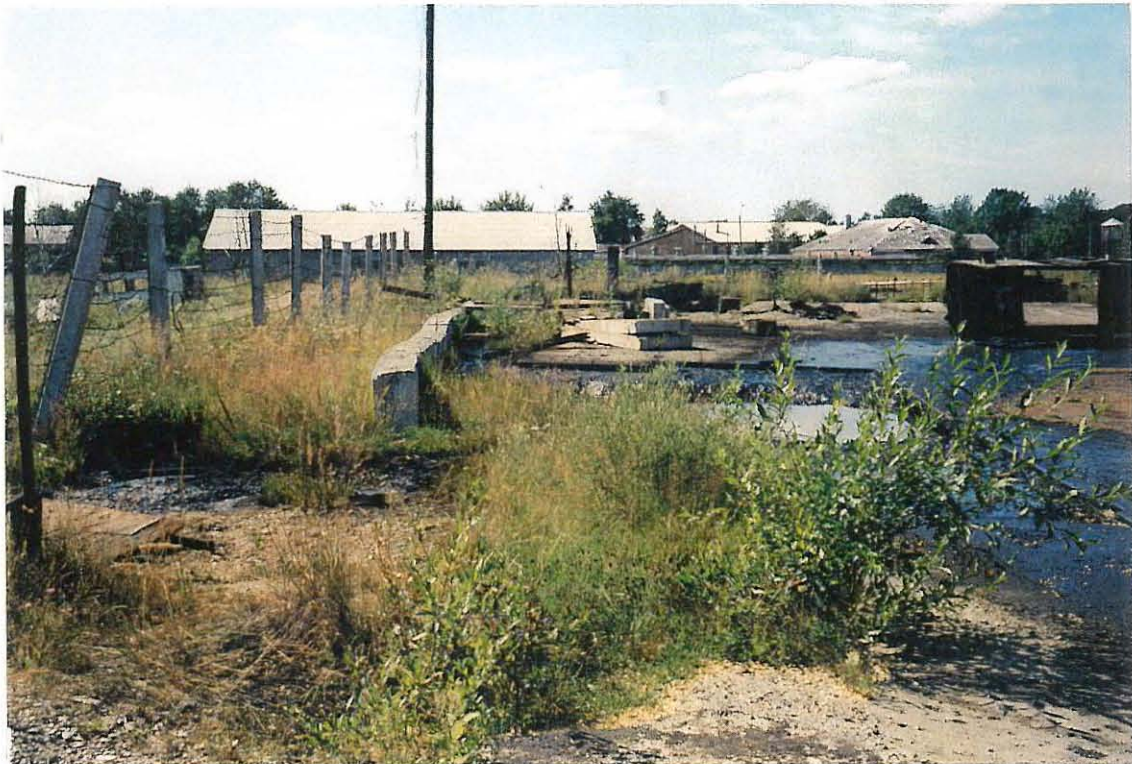
The ground surface is stained with oil near the railway in the southern part of the area. Inside the boiler house area, the ground surface is mainly covered with concrete slabs and oil can be seen only in pits, concrete channels and in other structures. In the northern part of the site, the ground surface is also stained with oil in parts of the area.

Photo 7. Oil and oily water flowing on the concrete slabs in southern part of the facility (viewed from the east).

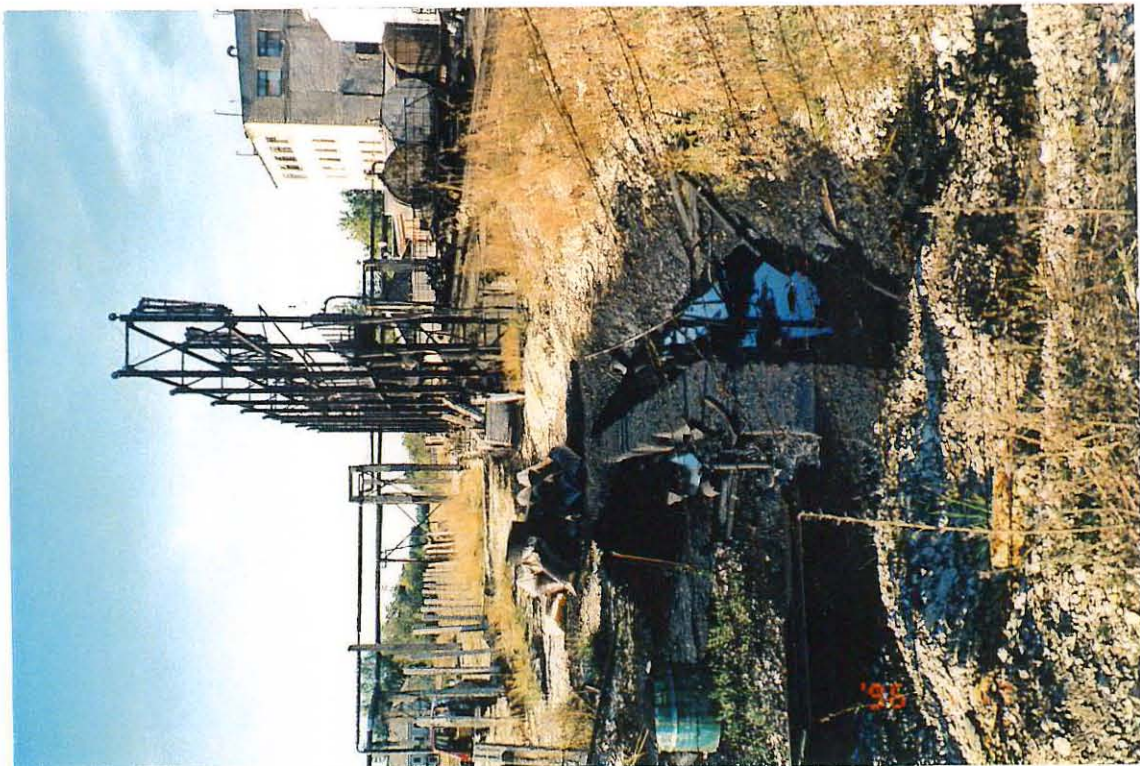
Photo 8. Underground concrete wall (viewed from the south).

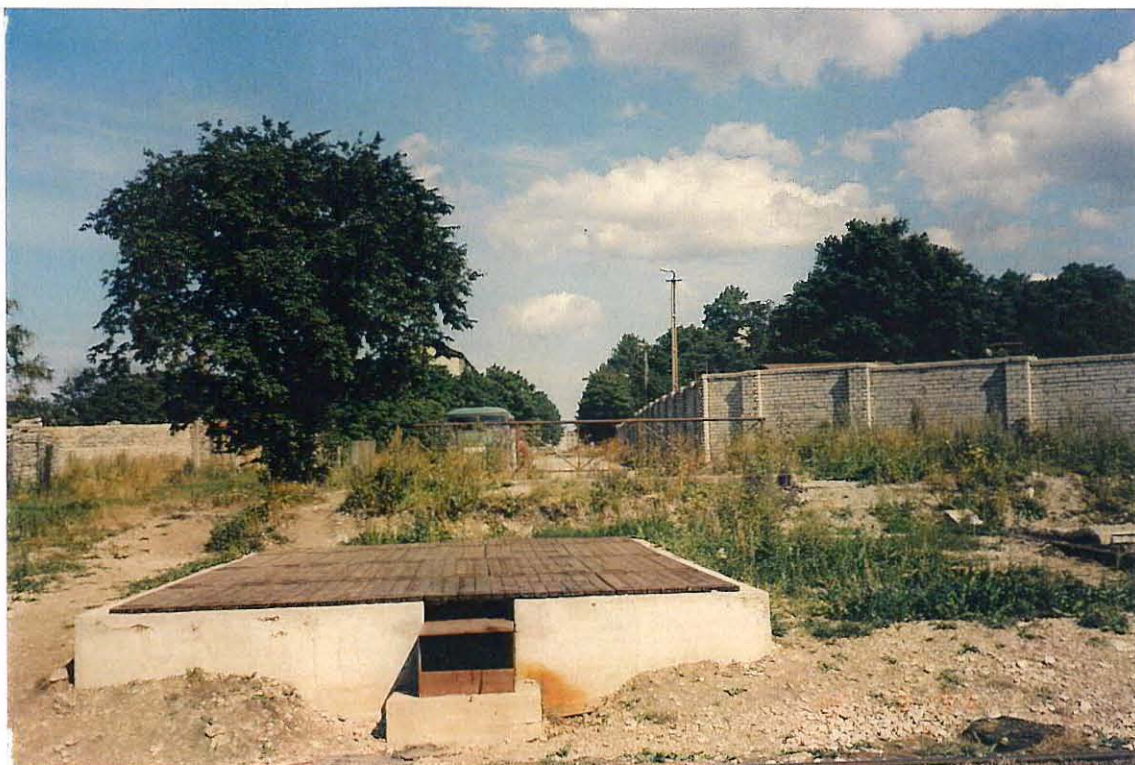
Photo 9. New oil separator near Paldiski Bay.

The oil separator should be emptied when needed, based on observations at regular intervals. The first section, in which the oil is collected, should be emptied on a regular basis to ensure that it does not fill up with water. If other sections are found to contain oil, it should be removed. When oil has been removed, the separator should be filled with water, except the first section, which should remain empty.

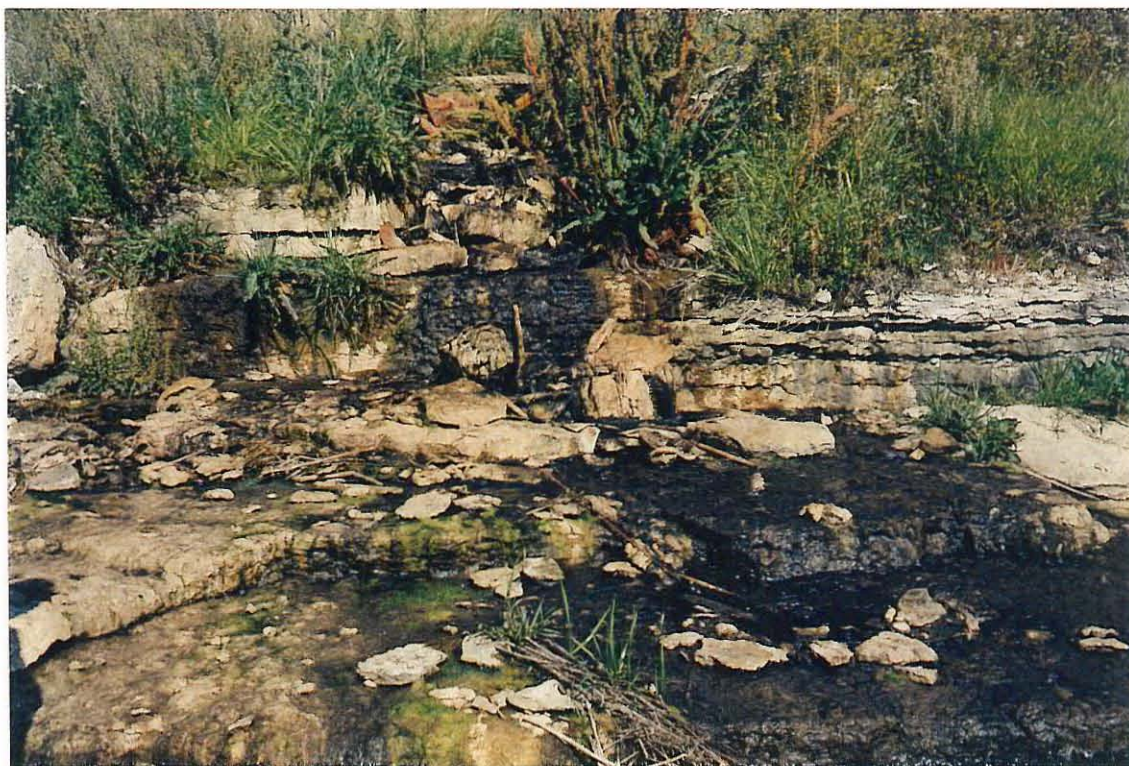
Photo 10. Limestone at the coast stained with oily water from the oil separator.

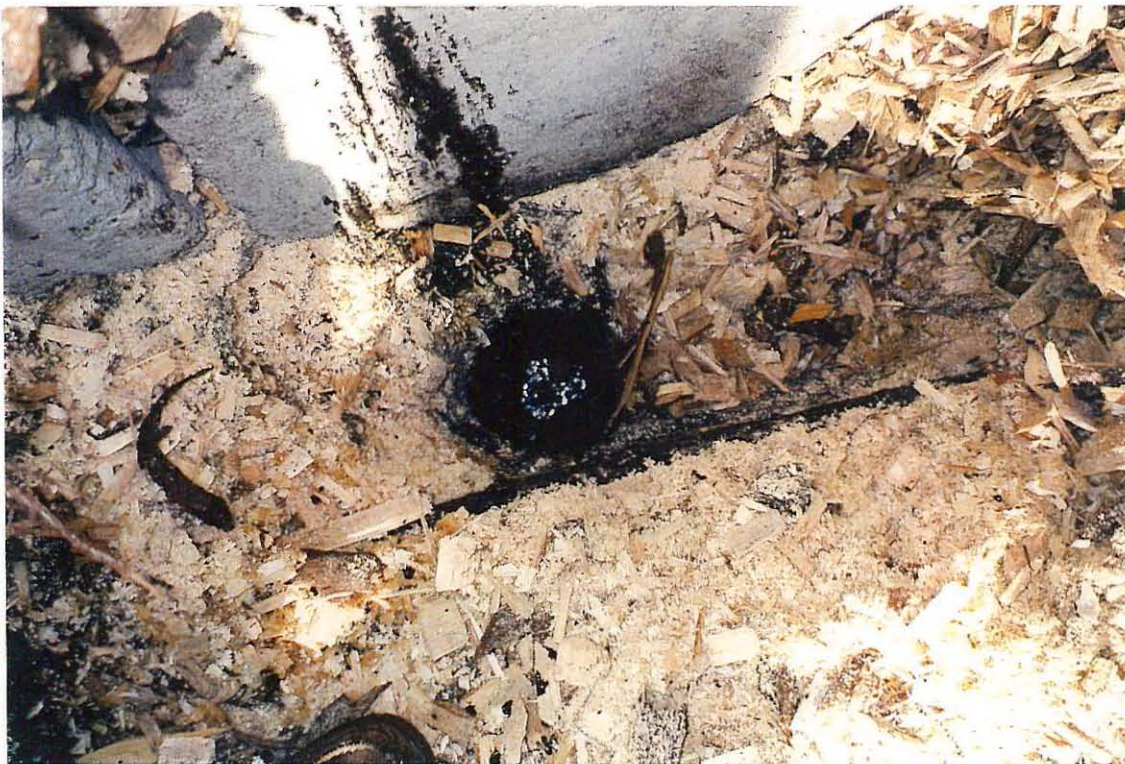
The most contaminated sampling points were the boreholes PA-4 and PA-20 in which free phase oil was observed (photos 11 and 12). Soil sample PA-4 was taken from the sand layer at a depth of 1.6 to 1.8 m which was under the oil layer. Pores in the soil samples PA-9 and PA-15 were partly filled with free phase oil.

Photo 12. Sampling point PA-4, depth of free phase oil about 0.7 m from ground surface.

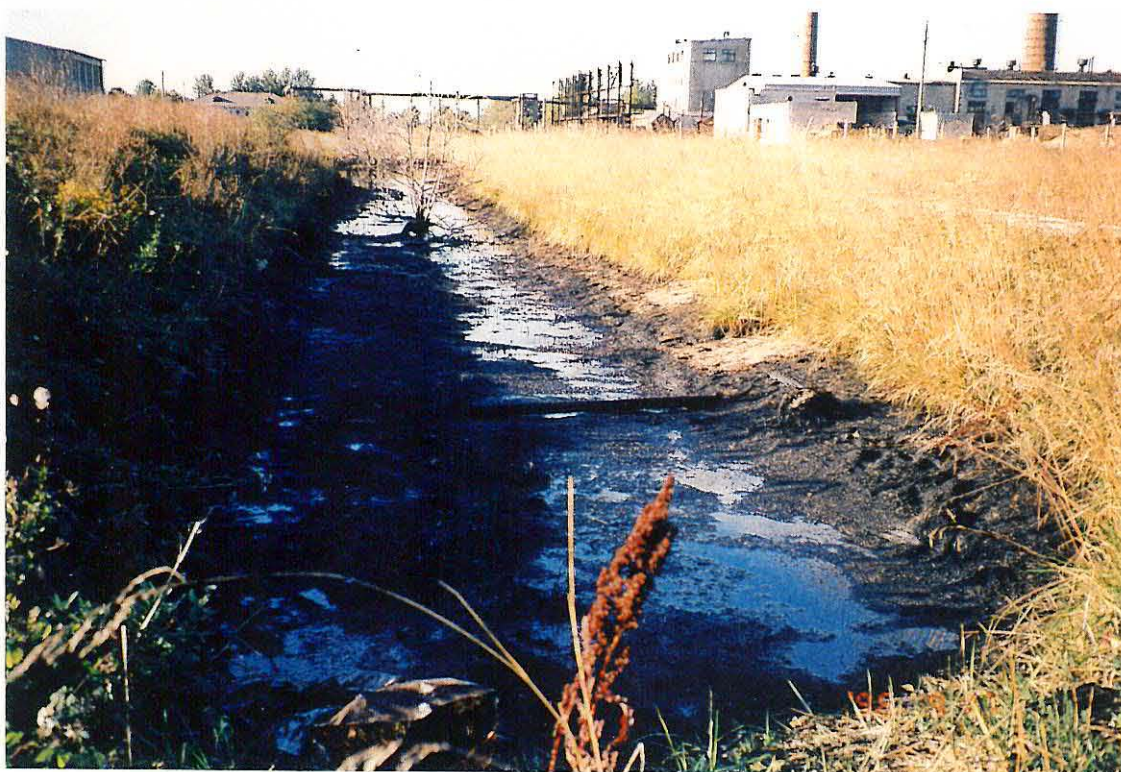
Free phase oil was observed in the concrete canals, drainage pipes, ditches and pits situated in the area of boiler house and to the south and west from the site. It was observed that when the water level rose, oil was spreading from the drainage pipes and the ground.

Photo 13. Drainage ditches in the South from the site (viewed from the Southeast)

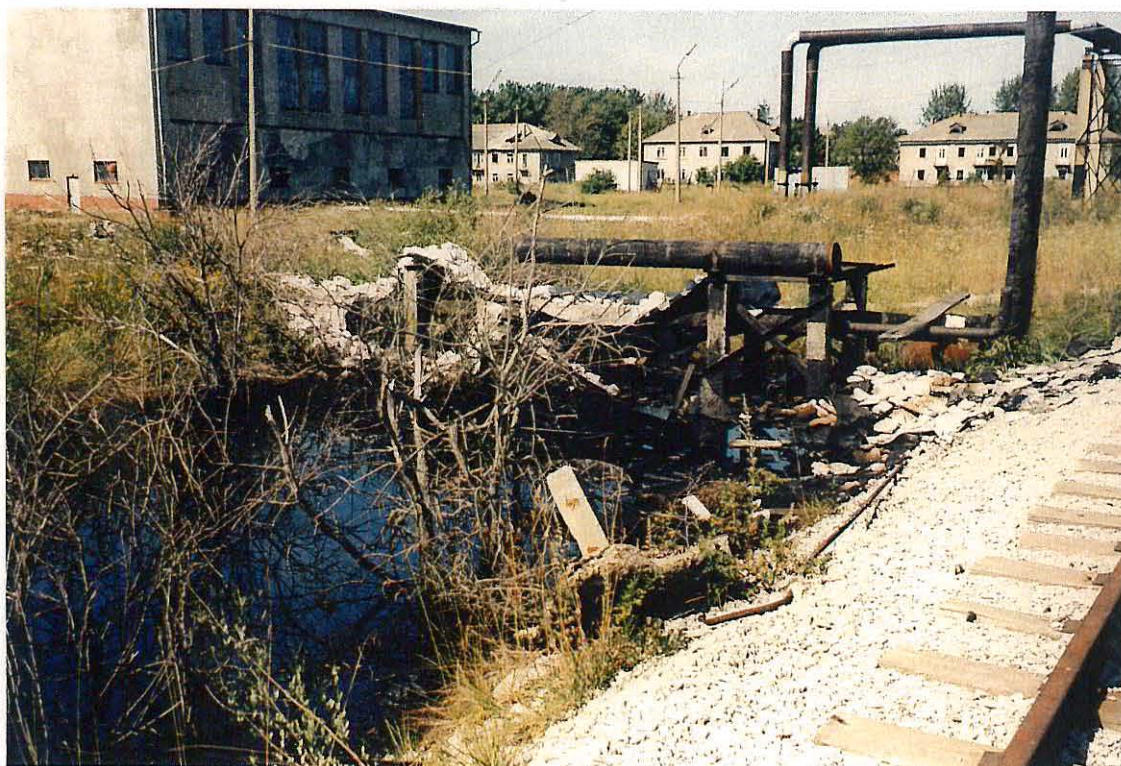
Photo 14. Oil in the drainage ditches on the Western side of the site.
