PALDISKI TOWN CENTRAL BOILER HOUSE

REMEDIATION FEASIBILITY STUDY

FEBRUARY 1997

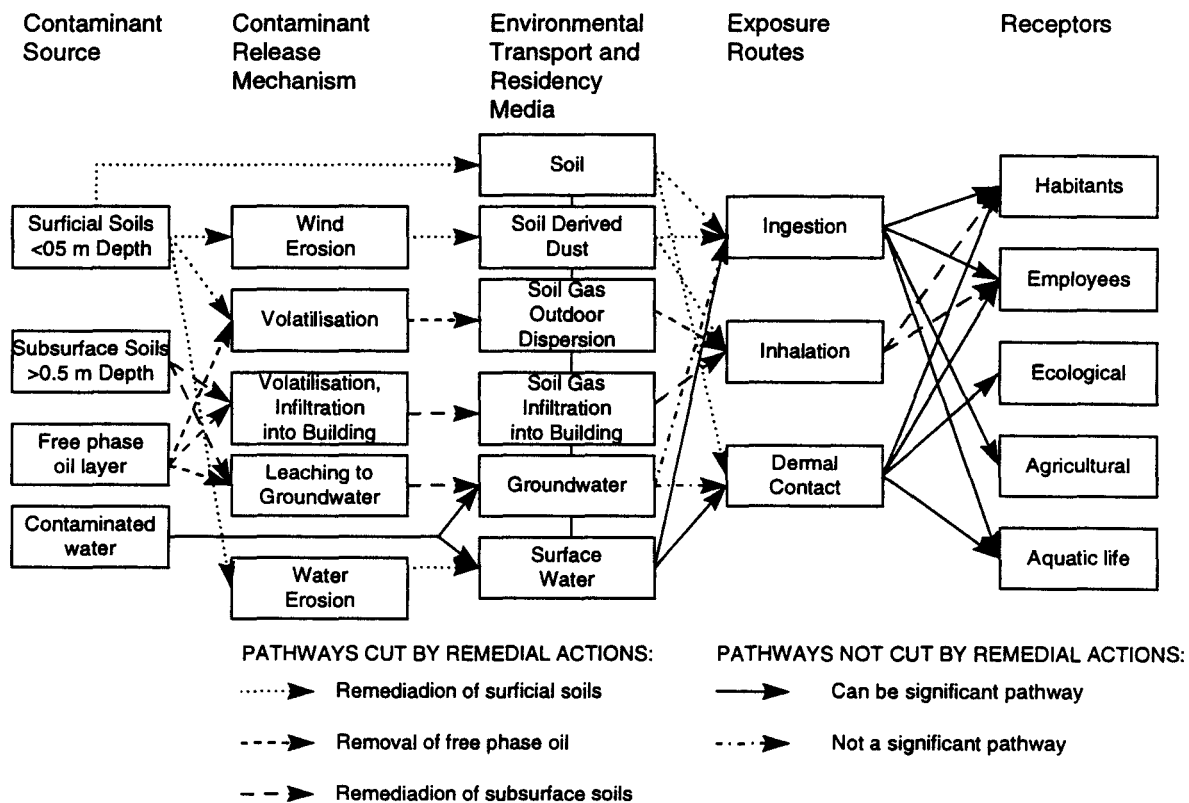
Figure 2. Conceptual model

All the potential exposure pathways are shown in figure 2. The dotted lines represent the pathways which will be removed by the proposed remedial actions for the site. The pathways marked with continuous lines will not be removed by the suggested remedial actions, but the pathways are not regarded as significant.

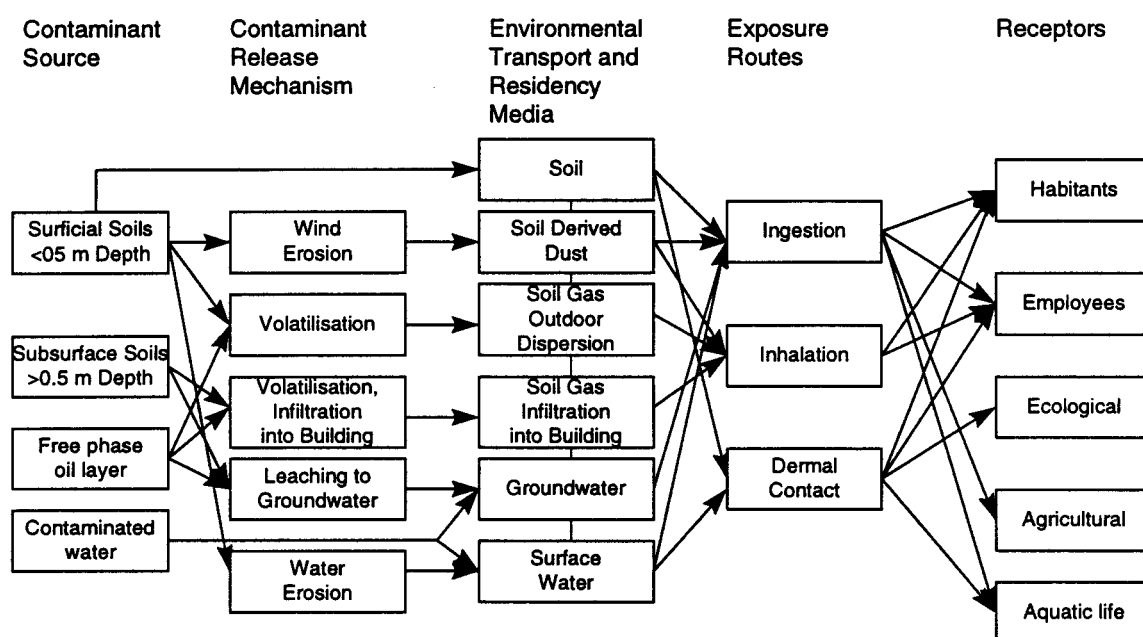
Figure 4.1 Preliminary conceptual model.

Surface water and water in the fill materials are heavily contaminated at the site. The uppermost groundwater aquifer in the limestone is contaminated with hydrocarbons (the water is not used for drinking). The second aquifer in upper sandstone layer is not contaminated (the water is used for drinking supply in some parts of Paldiski Peninsula, but not in Paldiski Town). The third aquifer is not contaminated. Paldiski is supplied with water from this aquifer.

The possible exposure pathways for every potential receptor are shown in the preliminary conceptual model shown in figure 4.1. Some of these pathways do not pose a significant risk due to the properties of the contaminants and the hydrogeological environment. Other pathways could be controlled by the proposed actions for the site, in other words by managing the risks.

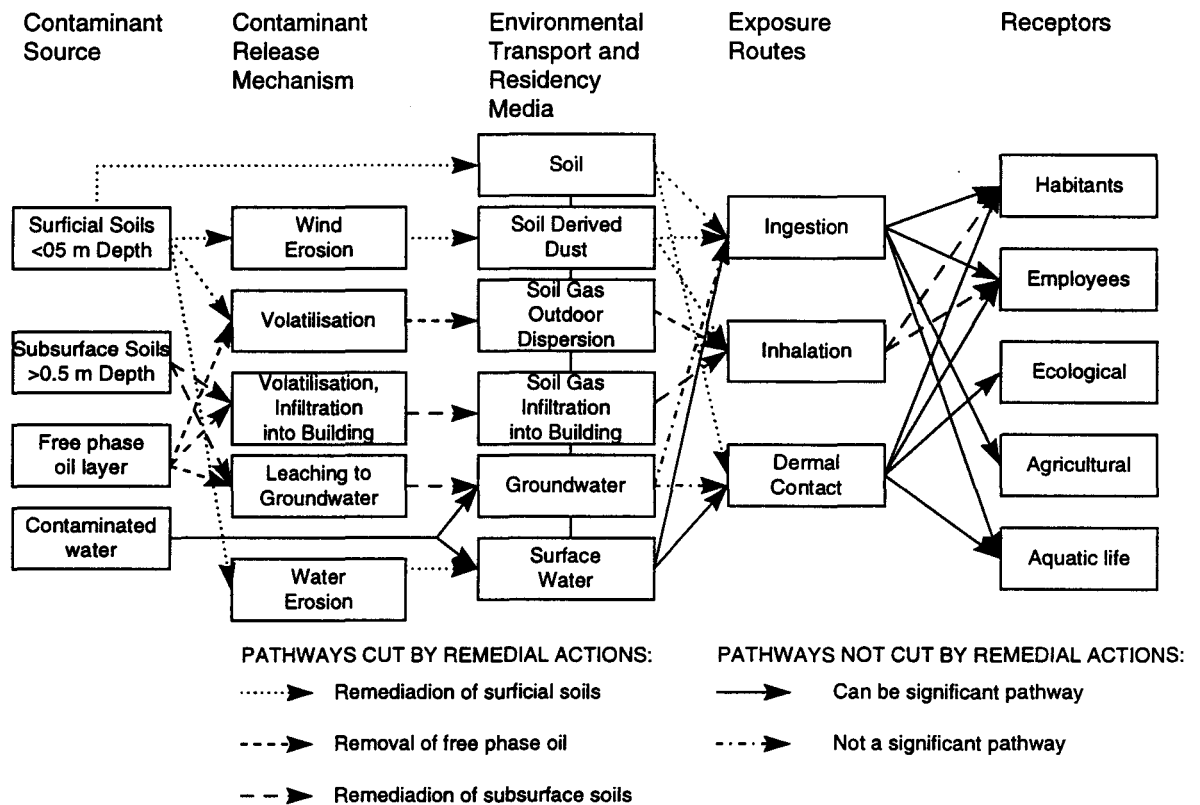
Figure 4.2 Conceptual model after risk management actions

The conceptual model, where risk management actions have been taken into account, is shown in figure 4.2. As shown, most of the potential pathways have been eliminated by the proposed actions, with contaminated surface water being the only remaining pathway that may pose a risk to human health and the environment. After implementing the suggested remedial actions, the risks associated with the contamination of surface water will decrease.

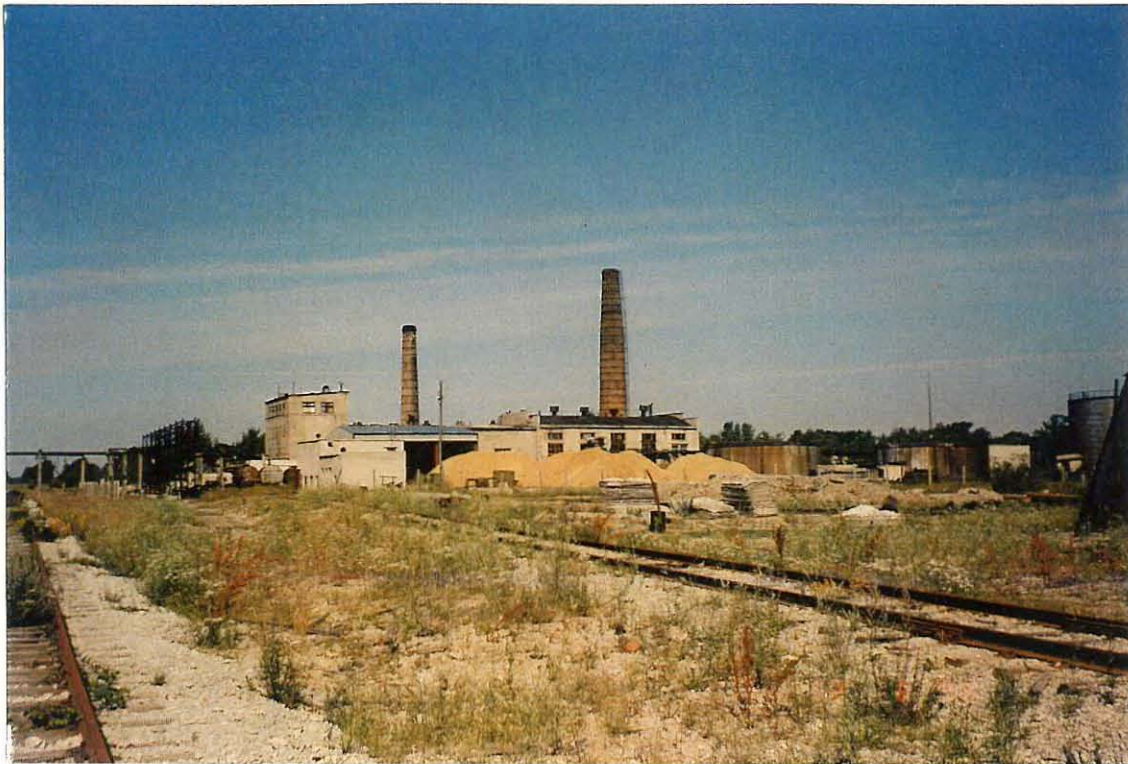
Photo 1. General view of the Central Boiler House (viewed from the south).

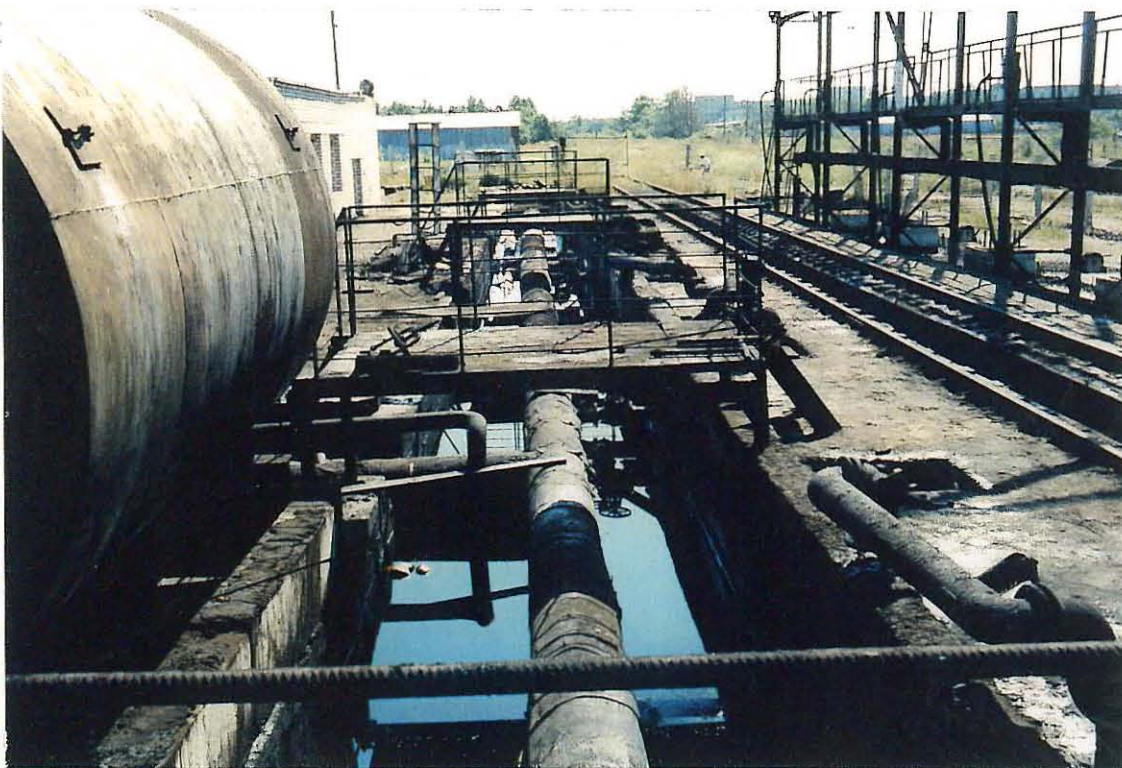
Photo 6. Railway junction for unloading of tank wagons.
